# Problematic

*fastener selection and joint design  
on display at RE+*

### Industry audit underway

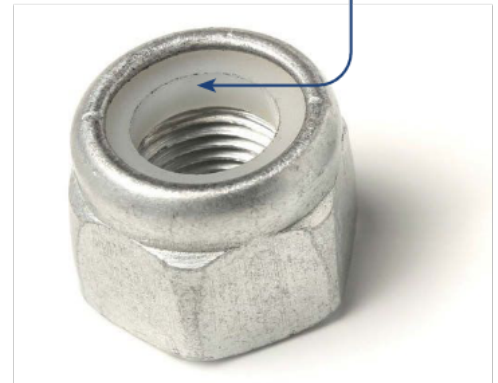
### Nylon Insert

The team also found the widespread use of nylon insert prevailing torque nuts, (or nylon lock nuts), as seen in Fig. 2. Although relatively inexpensive and effective at preventing the fastener from falling out, nylon lock nuts are not effective at keeping the bolted joint tight.

specified and assembled in the field. Nylon inserts are sensitive to and degrade from temperature, moisture and ultraviolet radiation (UV) exposure. Complicating cold weather installations, nylon degrades and becomes brittle at low temperatures and humidity, which can make them difficult to install successfully.

In some cases, the nylon rings crack, chip or are pushed out during assembly, making them ineffective. Another concern is the nylon becomes brittle when exposed to ultra-violet (UV), making them ineffective unless blockers or stabilizers are added to the nylon.

And lastly, nylon lock nuts are often mated with stainless steel bolts. Unfortunately, galling often occurs during the assembly of stainless steel, especially if the threads have not been lubricated. This is especially true for nylon lock nuts.

Figure 2: The use of nylon lock nuts can be problematic in solar pv joints unless they are properly specified.

When specifying nylon lock nuts, be sure to require UV-resistant nylon and require that a pre-applied lubricant such as wax be applied to the nut to reduce the likelihood of galling during assembly.

To reduce the risk of the nylon, insert cracking or push-out when assembling in low temperatures, and be sure to keep the nuts warm before use. Alternatively, skip the nylon lock nut altogether and instead specify a device that is rated to resist self-loosening under conditions of long-term exterior exposure.
